## FACILITY STATUS CHANGE FORM

<b>Date Submitted:</b> April 17, 2013 <b>Originator:</b> Chris Strand <b>Phone:</b> 554-2720	<b>Area:</b> 300 Area <b>Facility ID:</b> 327 and 3723 <b>Action Memorandum:</b> Action Memorandum #2	<b>Control #:</b> D4-300-062
---	--	---------------------------------

## Attachment 1: Facility Information

327 & 3723 FACILITY COMPLETION

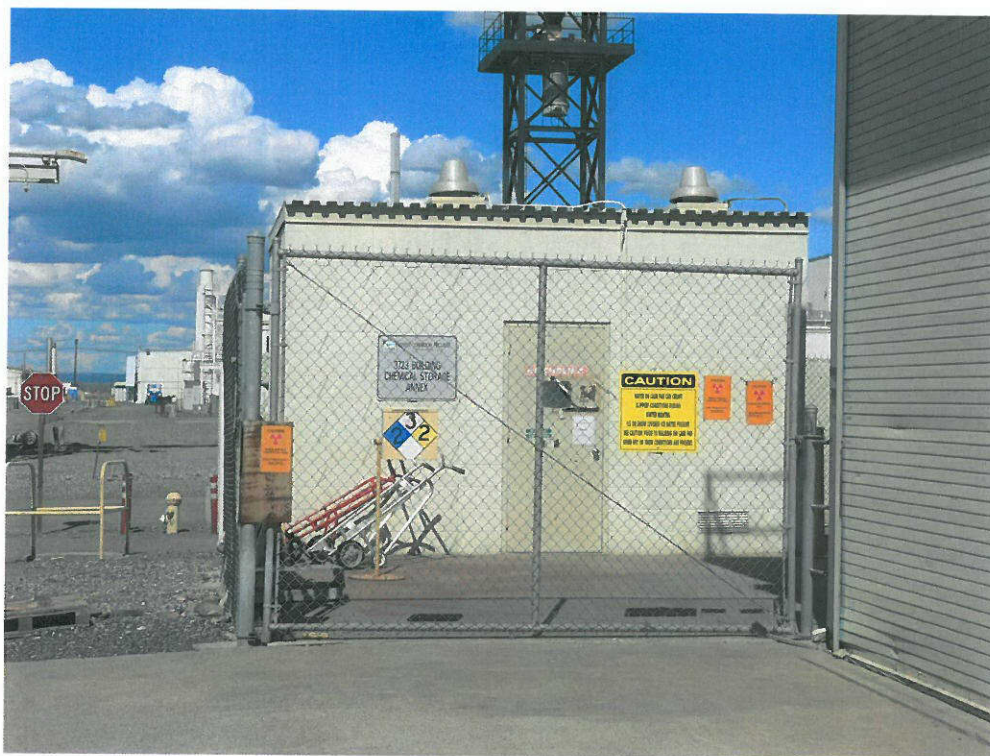
**Figure 3. Looking north at the 3723 Building on March 31, 2006.**

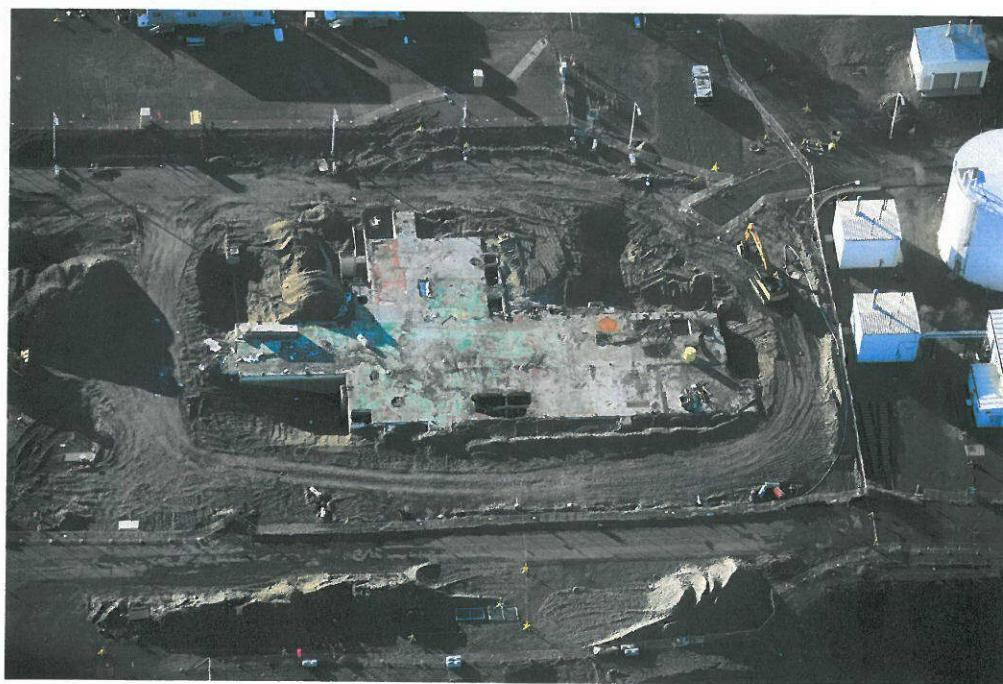
**Figure 4. Aerial view looking south at 327 and 3723 during above-grade demolition on January 19, 2011.**

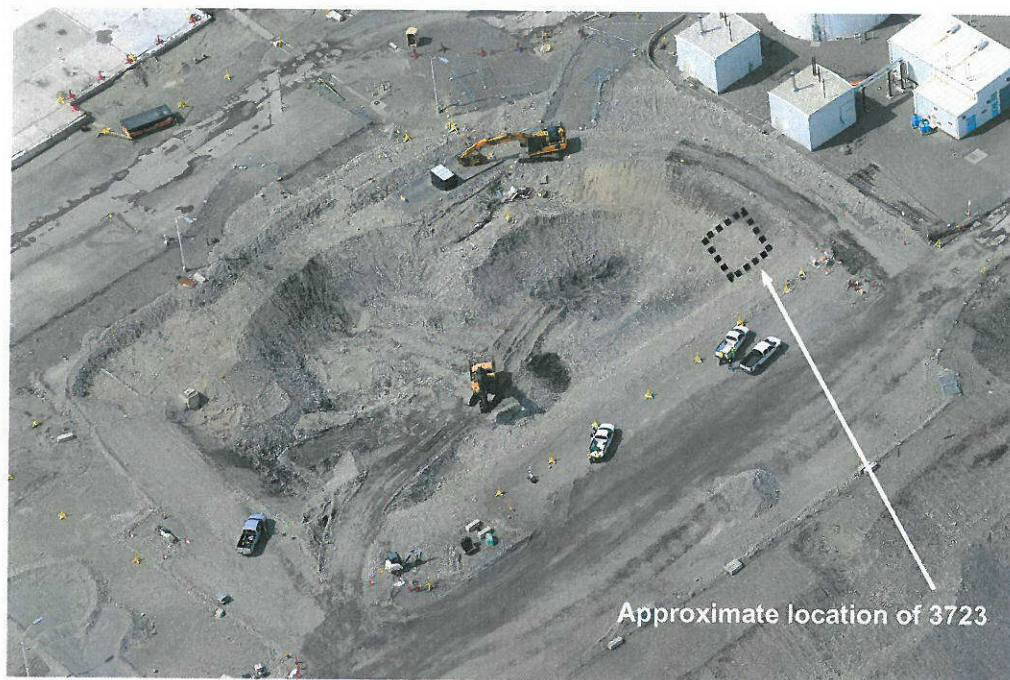
**Figure 5. Aerial view looking southwest at 327 and 3723 during below-grade demolition on May 29, 2012.**

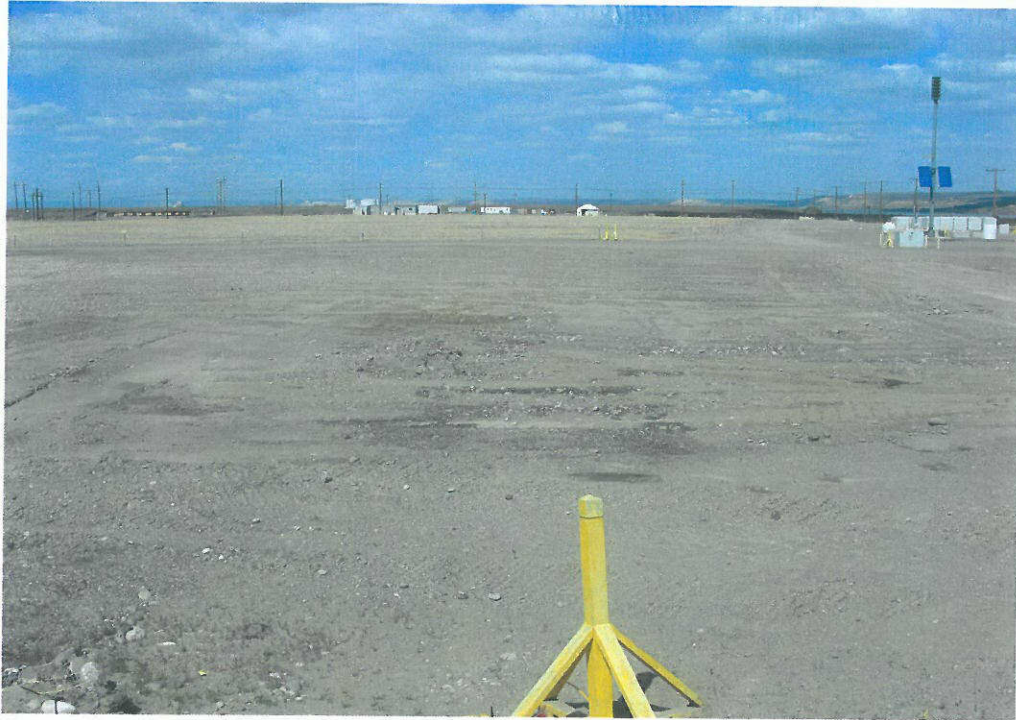
The 327 and 3723 excavation was backfilled to grade with clean soil to grade. Final grading will be performed following remediation of waste site piping remaining in the area. Radiological postings associated with waste site piping remain.

**Figure 8. Looking north at the final east area excavation following backfill on April 16, 2013.**

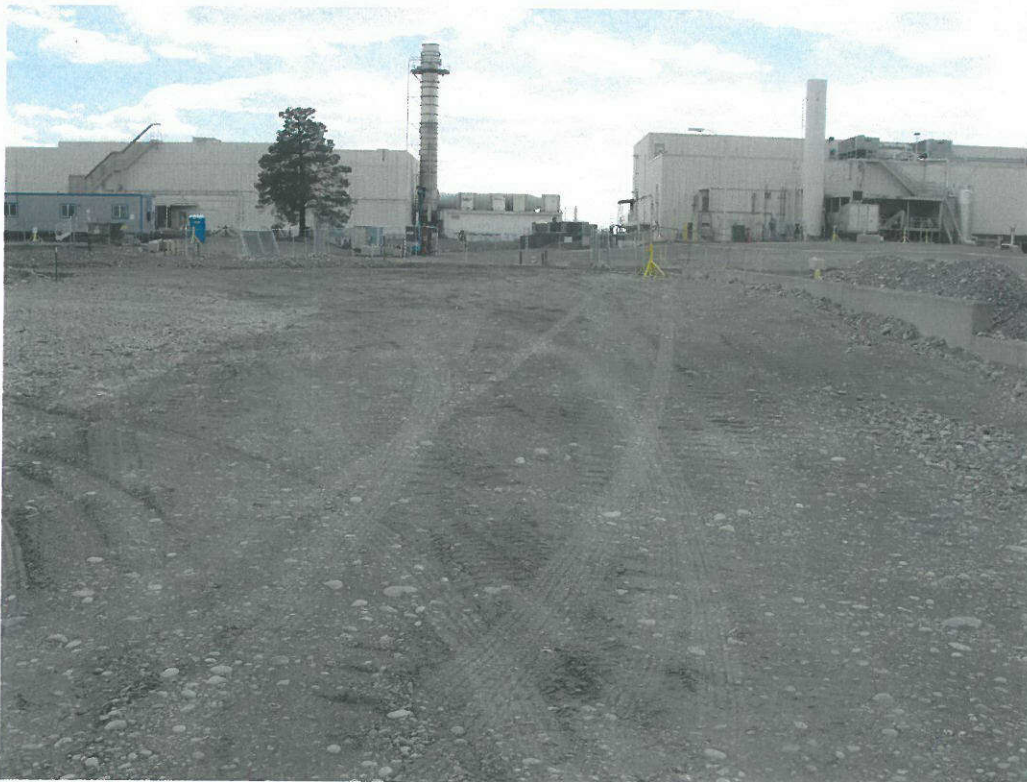
**Figure 9. Looking south at the final west area excavation following backfill on April 16, 2013**
